Invoice for RO #3730

Vehicle: 2017 Porsche Macan Turbo

COMPREHENSIVE VEHICLE CONDITION REPORT

Vehicle Details

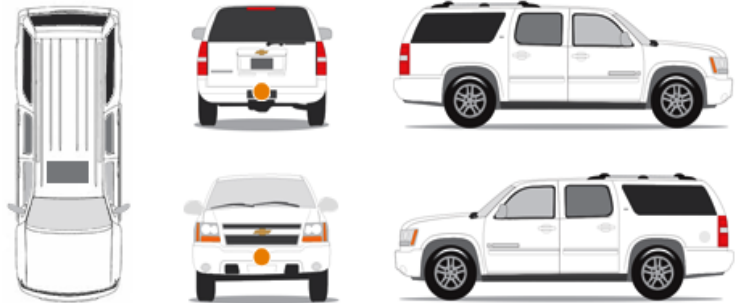
Exterior Body Inspection (Cosmetic)

The highlighted points on this vehicle diagram indicate the general areas where our inspection found prior repairs. These issues are not structural in nature and are considered to be purely cosmetic.

| Front Bumper Cover | Needs Refinishing |
| Rear Bumper Cover | Refinished |
